# Manhole Inspection Summary

Manhole # S08AA2012MH

Insp Date: **6/29/06 12:25 PM**

**Location** Address: **4101 CREST HEIGHTS RD**

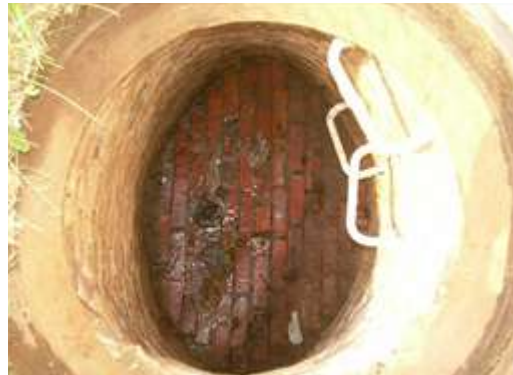
Top View

Channel debris.

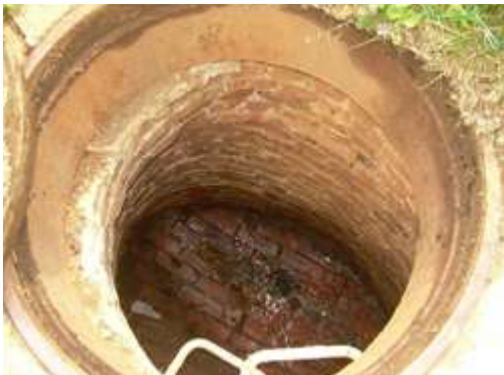
Defect

Frame leaks. Adjustment deterioration and infiltration. Barrel infiltration - other side.

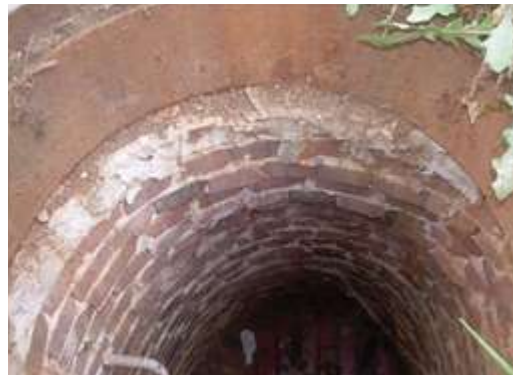
Defect

Adjustment and Corbel deterioration and infiltration - other side.

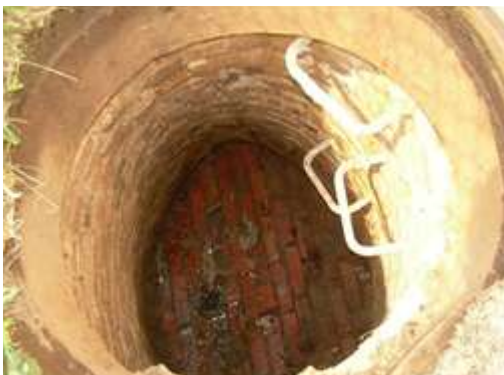
Defect

Frame leaks. Adjustment deterioration and infiltration. Barrel infiltration.

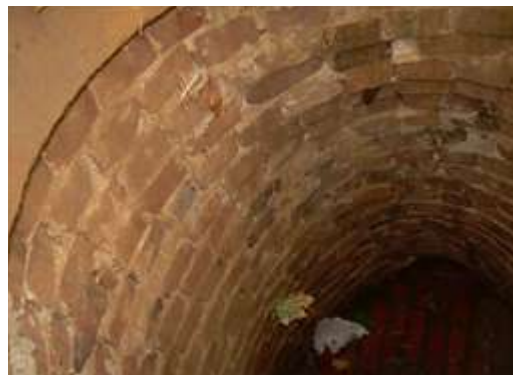
Defect

Adjustment and Corbel deterioration and infiltration.

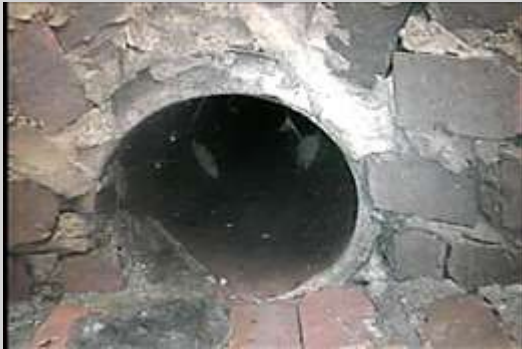
### 8 in. Circular Gravity Sewer Pipe Out @ 12 O'Clock

Barrel deterioration and infiltration.

Deposits: ☐ None ☒ **Mud** ☐ Sludge ☒ **Debris** ☐ Grease

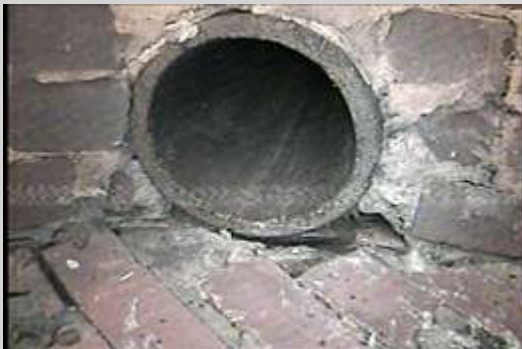
### 6 in. Circular Gravity Sewer Pipe In @ 7 O'Clock

Channel deterioration.

Infiltration: **Evidence** Pipe Seal Cond: **Unknown**
